Final Report
for
Iowa Department of Transportation
Project HR-504

Galvanized Bridge Deck Reinforcing

December 1992

I-35 over Long Dick Creek
Story County

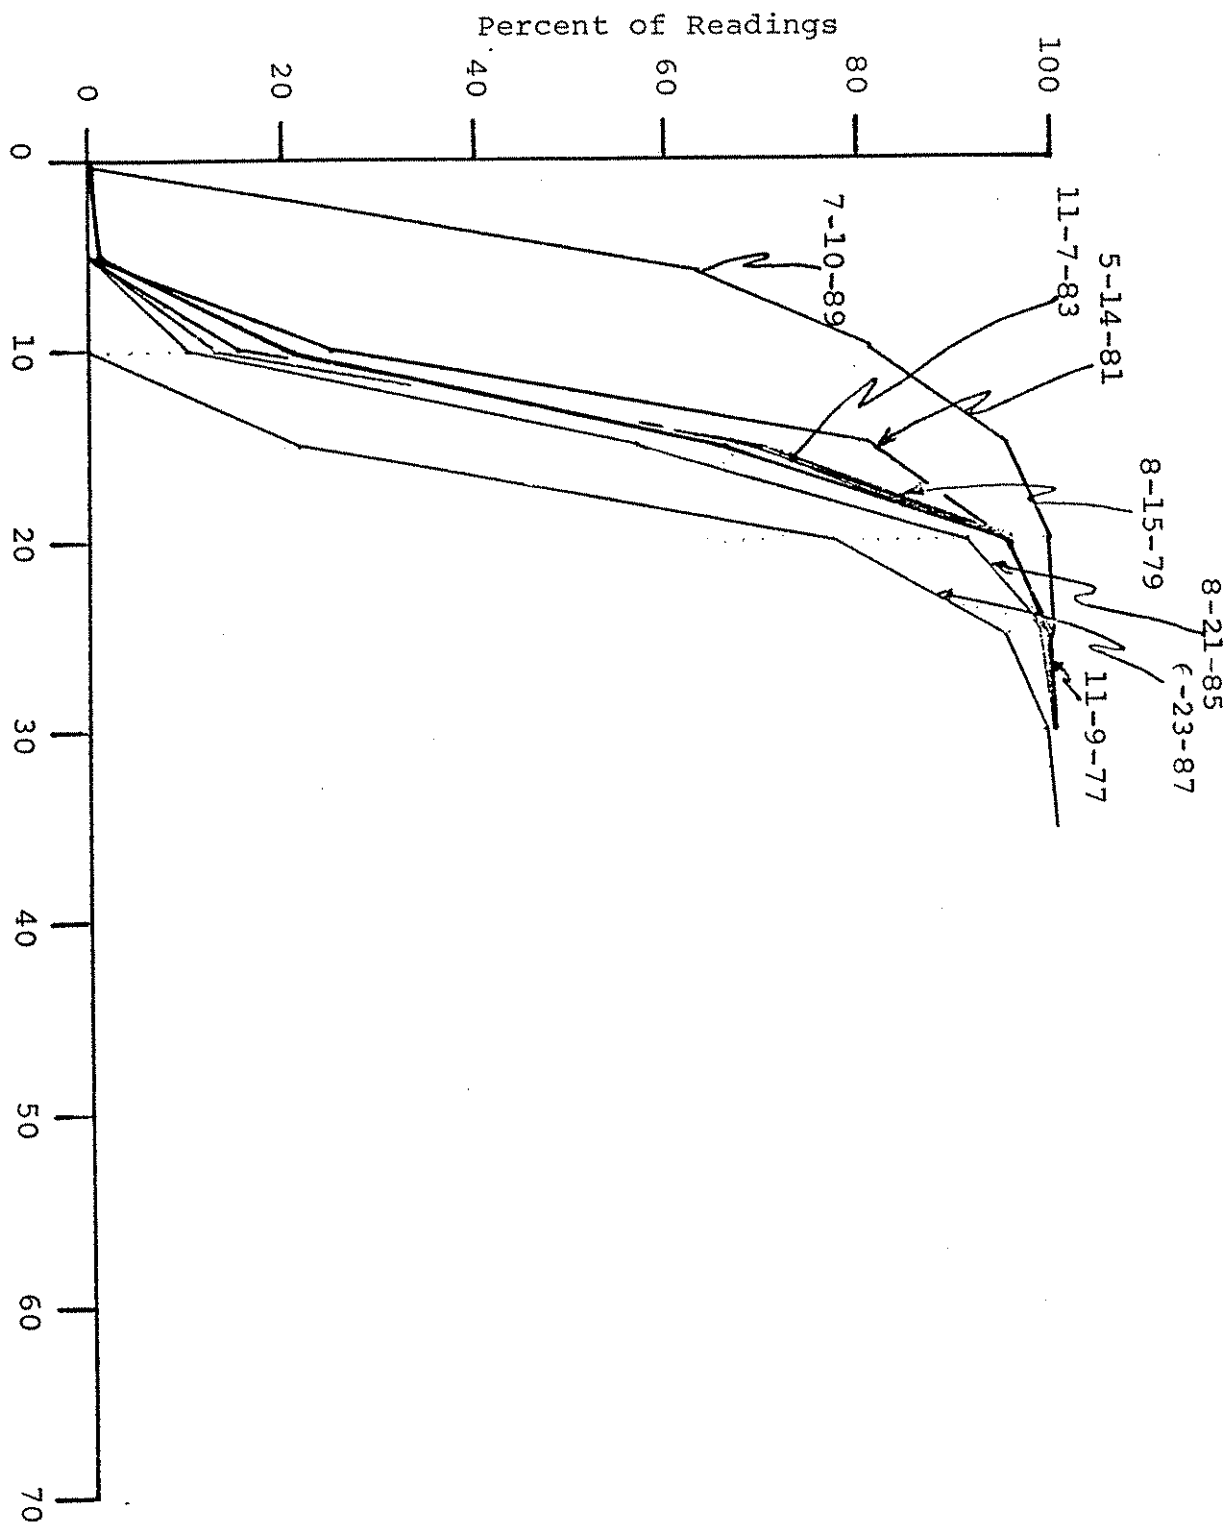
Electrical Potential (x .01 v)
 I-35 Northbound over Long Dick Creek - Story County
 Galvanized Steel in Part of Deck
 Constructed in 1967

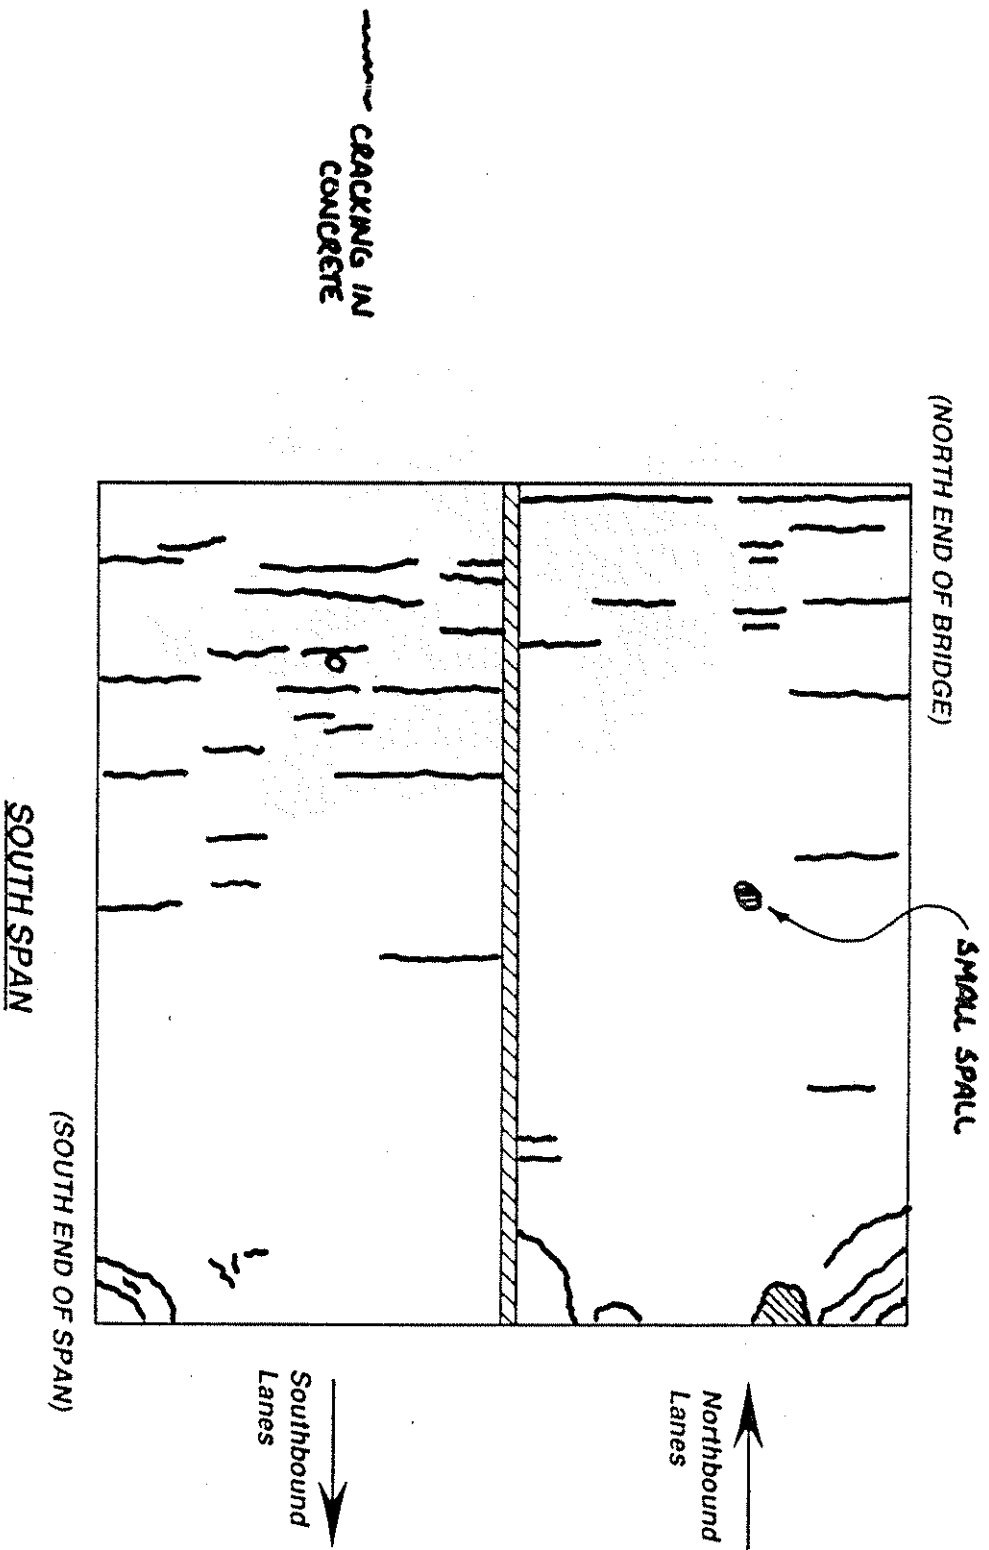
CRACKING IN
CONCRETE

Representative Conditions of Bridge Deck Wearing Surface (Note areas of concrete deterioration and asphalt patch shown in Photo b)
